Safer Schools, Resilient Communities

A Comparative Assessment
of School Safety after the
2015 Nepal Earthquakes

Rebekah Paci-Green
Bishnu Pandey
Robert Friedman

August 2015
Risk RED

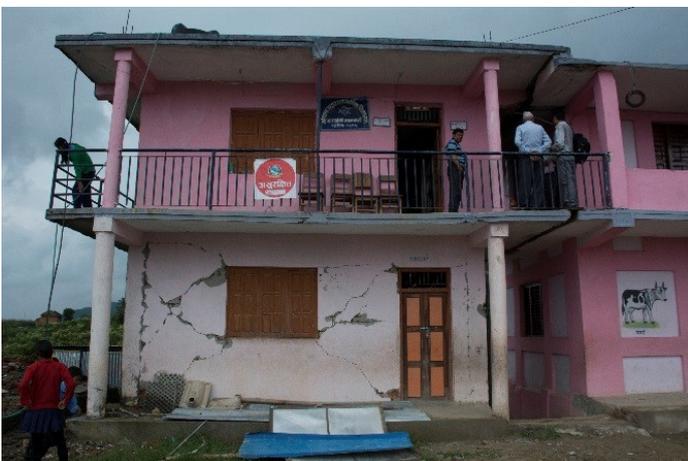
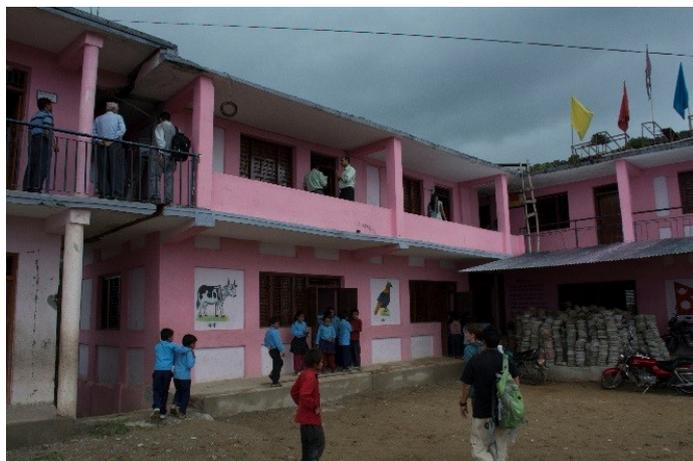
Figure 1. At a school in Kathmandu, two school buildings on the same sight performed very differently. The building on the left, a reinforced concrete frame structure with brick infill walls, was moderately damaged and received a red tag. Its frame joints and infill walls will need to be repaired before the building can be reused for classrooms. The building on the right, an adobe and stone masonry structure, was recently retrofitted with stitch banding. It was undamaged and immediately able to be reopened, despite being made of a weaker building material. The retrofit proved to be successful. Photo: R. Friedman/ Risk RED

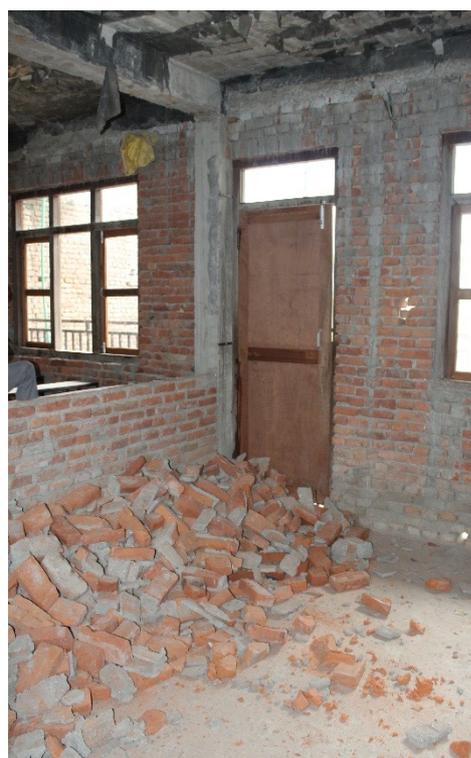
Infill Walls. Infill walls of brick or stone are added between columns to form exterior walls or to partition classrooms. During the earthquake, many infill walls cracked where they connected with beams and columns. Others developed more noticeable damage at corners or even diagonal shear cracks.

At the schools observed, the infill walls did not have vertical or horizontal reinforcing steel to support them, a common practice prescribed by international building codes and the NBC. When they cracked, as is expected in an earthquake, they became unstable because of the lack of reinforcing or other means of holding them to the frame.

Cracks in these infill wall, although considered minor damage from a structural engineering perspective, were a serious problem in schools. Teachers and principals would demonstrate by pushing on the cracked walls, causing the walls to visibly move. With the risk that these walls could topple over and crush occupants in future aftershocks or earthquakes, many schools with infill wall damage were

Figure 2. School building 101-1, which experienced only moderate shaking in Bhaktapur, was deemed unsafe for school use because unreinforced partition walls separated from the reinforced concrete frame and became unstable. Damage to unreinforced partition or infill walls can injure or kill students and block exits. The safety of these walls is routinely ignored by engineers and communities alike. Photo: R. Paci-Green/Risk RED

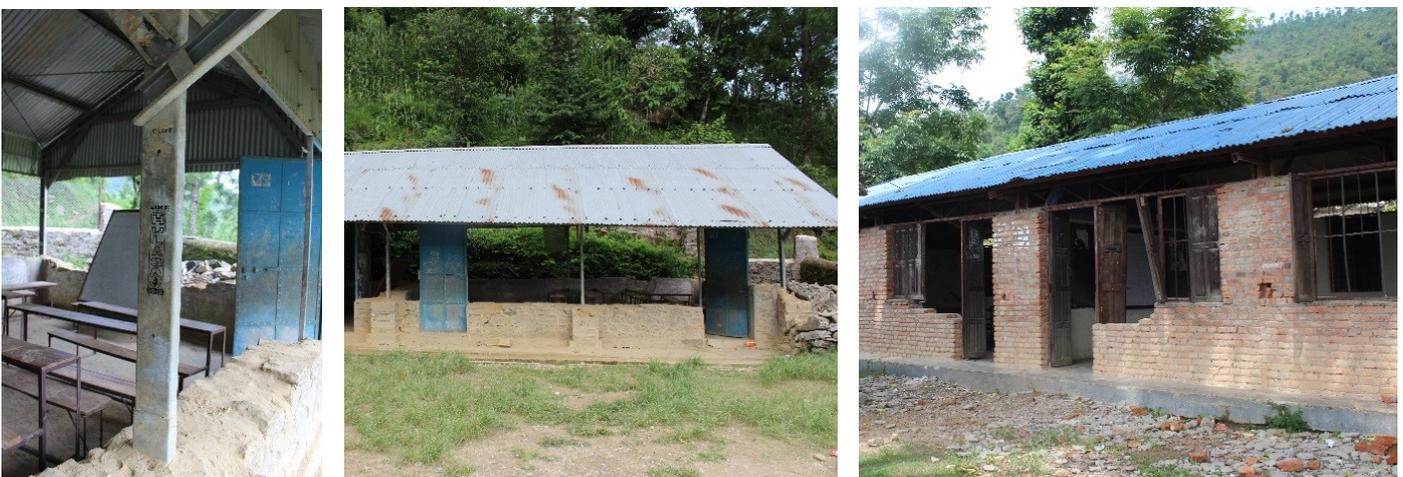
In semi-urban and urban areas, communities built unreinforced brick walls around the frames; in rural areas, they often used stone and mud to build the walls. A review of the design drawings of one of these structures does show detailing for a reinforced concrete lintel band on the top of the walls and reinforcing at wall connections. However, these elements of the design were not observed in any of the six metal frame school blocks we assessed.

Figure 3. Metal frame template designs are common in rural and remote areas. While the frames were undamaged in the earthquake, the stone and mud mortar walls that used to enclose the school collapsed. These walls were considered non-structural. Communities were allowed to build them with available materials and without reinforcement. The vast majority of the stone walls collapsed down to about half a meter, showering the classroom with large, deadly stones. Brick walls were typically damaged and unstable, but collapsed less often. [Note: Rubble from collapsed stone and brick had already been removed when photos were taken.] Photo: R. Paci-Green/Risk RED

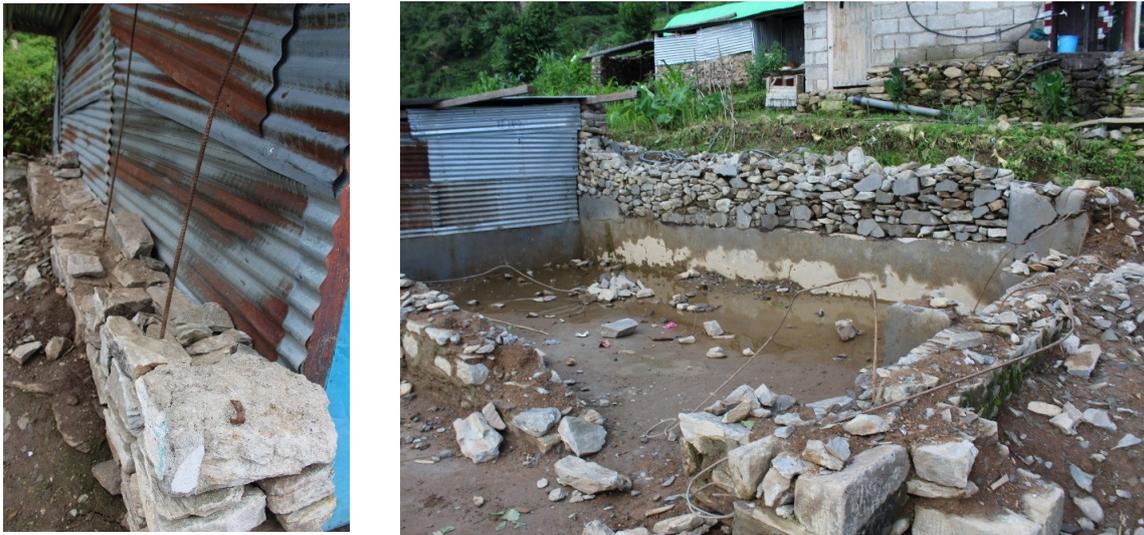
The second design, derived from NBC provisions and also featured in masonry guidelines in India, added vertical reinforcing bars at every corner and wall opening within stone and mud mortar walls. In all schools observed with this design, the bars proved completely useless and the stone fell away from the bars. These buildings completely collapsed. We observed wood bands used in some of the schools built with this design, but not others.

Figure 4. A Ministry of Education template design, which called for vertical rebar to be placed in stone walls, completely collapsed in every block assessed with this design. While now removed, after the earthquake, the classrooms were filled with stone from the collapsed walls. Photo: R. Paci-Green/Risk RED

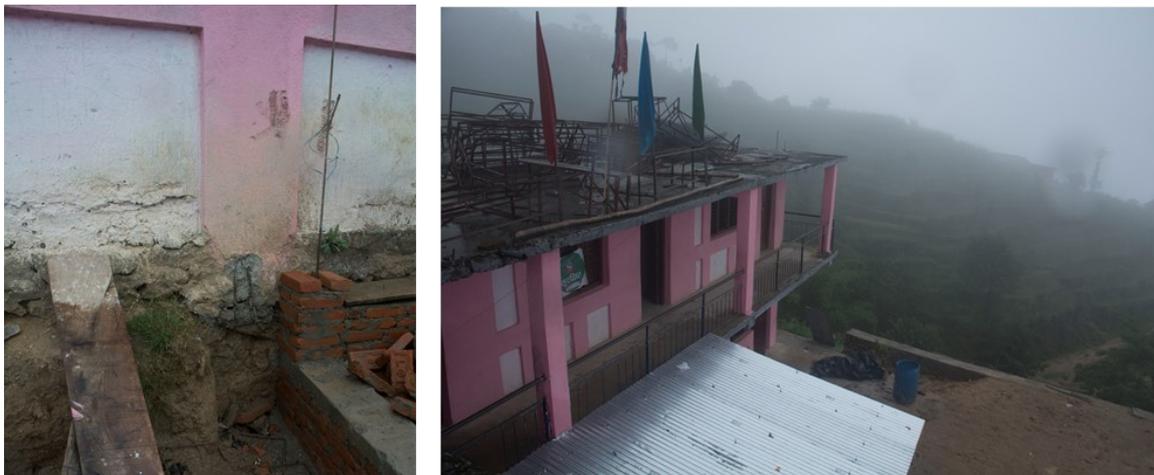
While the four retrofitted schools in Kathmandu and Bhaktapur were undamaged, we found several lapses in design or construction at one site. At the base of the walls, the masons had created a stitch band beam. However the band was discontinuous on one side of the block; vertical bars came down and poked out of the bottom. On the roof, vertical bars continued up through the ceiling slab and were bent over only a short distance. These ends of the vertical band bars were covered with a small 16-inch patch, leaving only 8 inches for bars to be bent in each direction. The distance was too small to allow the bars to develop their full strength during an earthquake. In a stronger earthquake, the bars would have popped through the small roof batch. More globally, the retrofit addressed the masonry walls of the school only. The retrofit did not jacket and strengthen masonry columns on the second floor balcony or add supports below the masonry columns. Without strengthening, these masonry columns could crumble in a larger earthquake, leaving the overhanging ceiling and floor slabs unsupported and in real danger of collapsing during the earthquake or when students filed out to evacuate.

Figure 5. While a retrofitted school in Kathmandu performed well in this earthquake, retrofit design and construction flaws may lead to unnecessary damage in larger events. In the left photo, vertical bars poke out the bottom of a retrofit band. A horizontal retrofit band at the bottom of the wall is missing on this side of the building. On the roof top, the vertical bars are secured by only small patches of concrete, partially covered in the photo by discarded school benches. The masonry columns supporting the roof overhang were not strengthened in any way and remain unsupported below the balcony overhang. Photo: B. Pandey/Risk RED

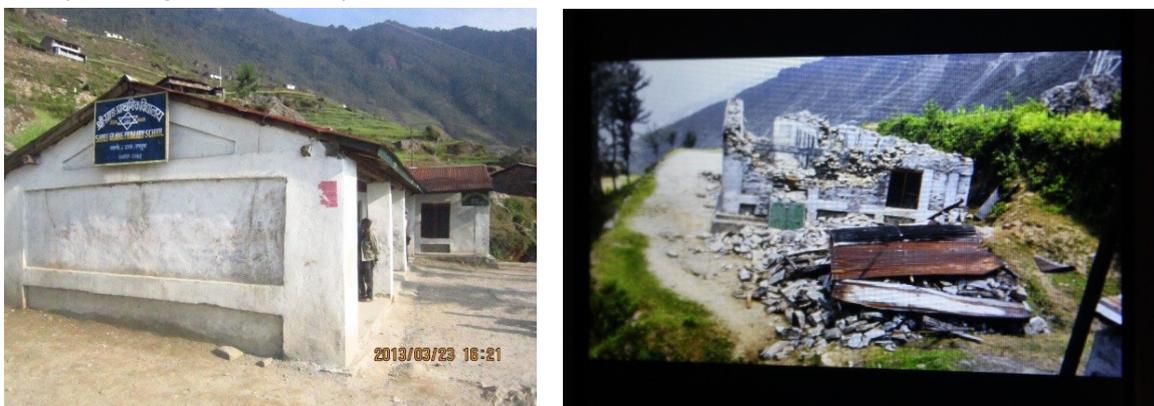
Figure 6. Donor-funded retrofit of a stone and mud mortar school in Rasuwa collapsed in the earthquake, as the principal captured and showed us on his smart phone after retrofit on the left and after the earthquake on the right. The rubble had been removed by the time of the survey. Little training of masons and nearly non-existent technical oversight ensured that when masons struggled to implement the retrofit design, the problems were not caught and rectified. The principal estimates 120 out of 140 students and staff would have died. Photos courtesy of school principal.

The failed retrofit project had even less adaptation to the limitations of the brittle stone building material. Local workers found it impossible to adapt the stitch band retrofitting technique to stone masonry; they simply could not drill through the stone walls to stitch bands together. But, the project implementation had no plan for adjusting the technology or stopping an unsafe solution. The result was a catastrophic collapse. Had technical experts been involved in ongoing community engagement, they may have better understood the challenges of stone retrofit in a remote village and may have modified or abandoned the project for something more likely to be life safe.

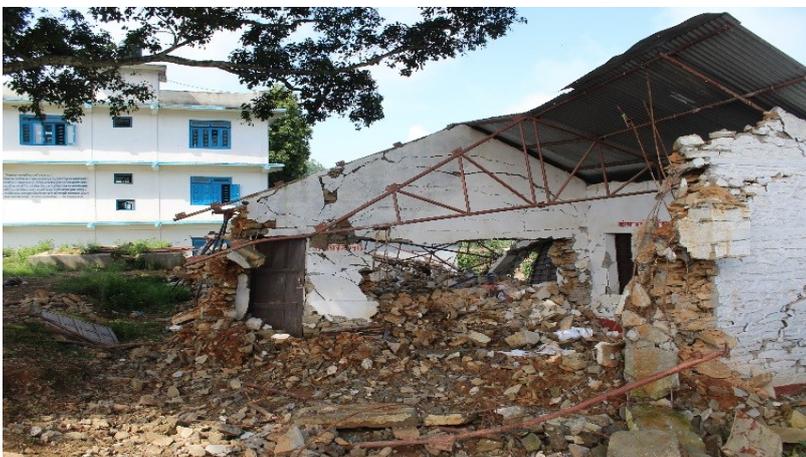
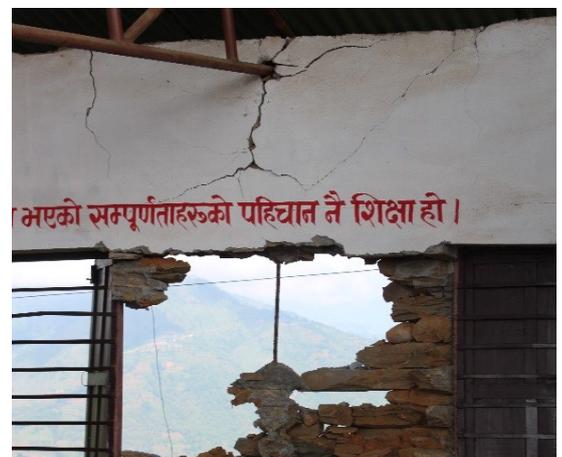
The widespread collapse of rubble stone buildings, even in a case where a lintel band and vertical reinforcement had been used, suggests that constructing safely with rubble stone is fraught with difficulties.

Figure 7. This teaching resource centre on school grounds was built with stone and mud mortar. The masons employed earthquake-safety measures, such as a reinforced concrete lintel band and vertical reinforcement in the walls. However, even with these measures, the heavy shaking in Sindhupalchowk caused the stone building to collapse swiftly and completely. It may be difficult to rebuild safe schools out of this brittle material unless alternative technologies are developed, tested and extensive mason training and strict oversight are feasible during construction. Photo: R. Paci-Green/Risk RED

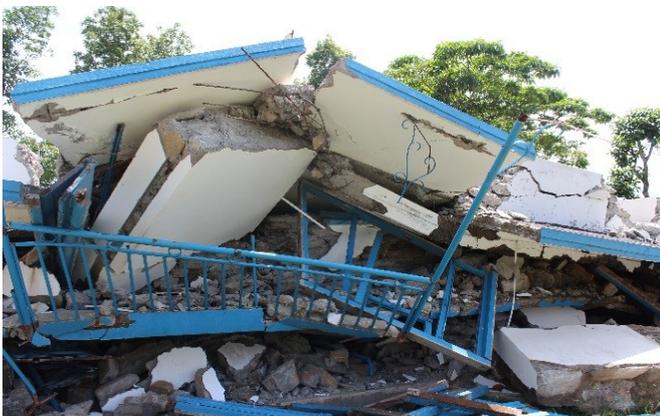
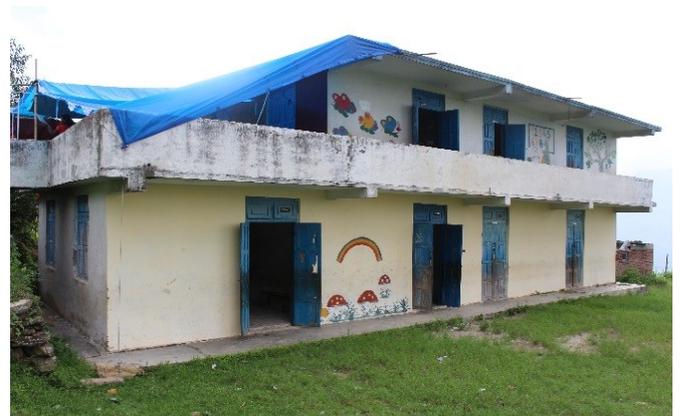
Figure 8. Two neighbouring schools were both built through international donor support. The left was built without technical support. The right was built after the community was given an orientation on earthquake safe construction and local masons were trained in safer construction techniques. An engineer and lead mason, both with experience in earthquake-safe school construction, carefully oversaw the process. After the earthquake, the second was operational; even the terrace had been covered and converted into a makeshift workshop for the local community. Photo: R. Paci-Green/Risk RED

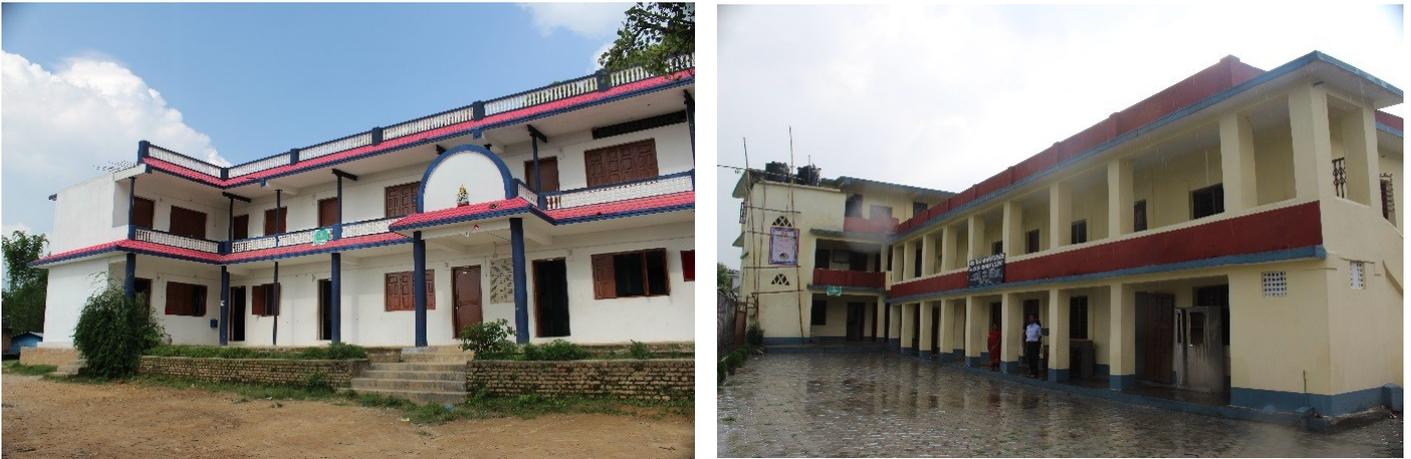
Figure 9. Community engagement in school retrofitting is vitally important in establishing the links between safe school facilities and best practices in school disaster management. Both school buildings shown were successfully retrofitted and undamaged in the earthquake. However, without community outreach and engagement, the staff and parents of the school on the left indicated they would have had students attempt to run out during the shaking, likely resulting in stampedes or students jumping from the second floor. The school would have likely experienced serious injuries and possible deaths. On the right, students and staff regularly discussed and drilled earthquake safety. Staff indicated students would have stayed in place during the quake, or dropped, covered and held on. The staff expected no injuries or deaths had the event happened during school hours. Photo: R. Paci-Green/Risk RED

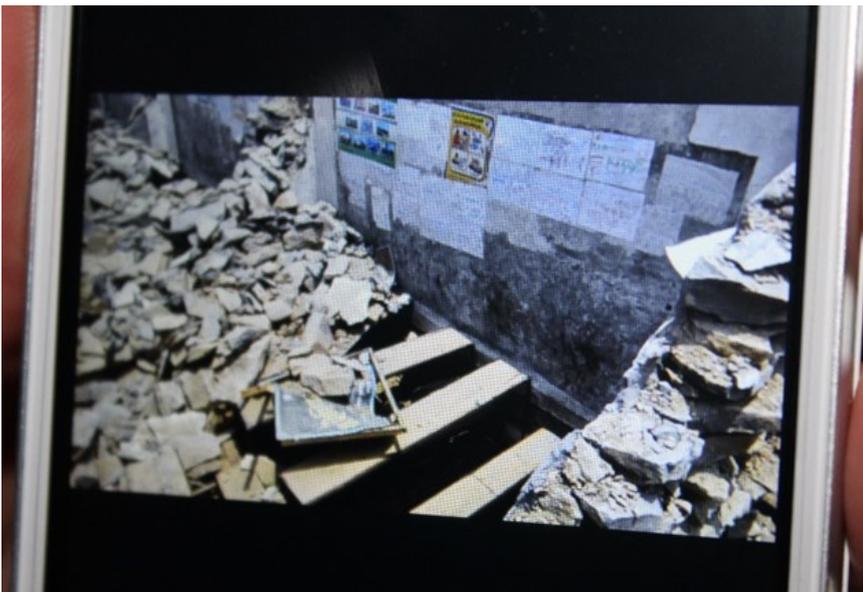
Figure 10. In Rasuwa, a poorly retrofitted stone school collapsed. Photos from the principal attest to the fact that few students would have been able to evacuate or survive the collapse.

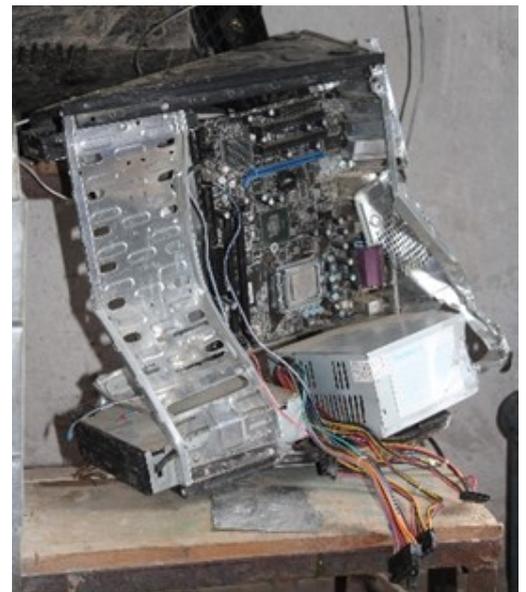
Figure 11. School computers and lab supplies were damaged where no non-structural mitigation measures had been taken. Photo: R. Paci-Green/Risk RED

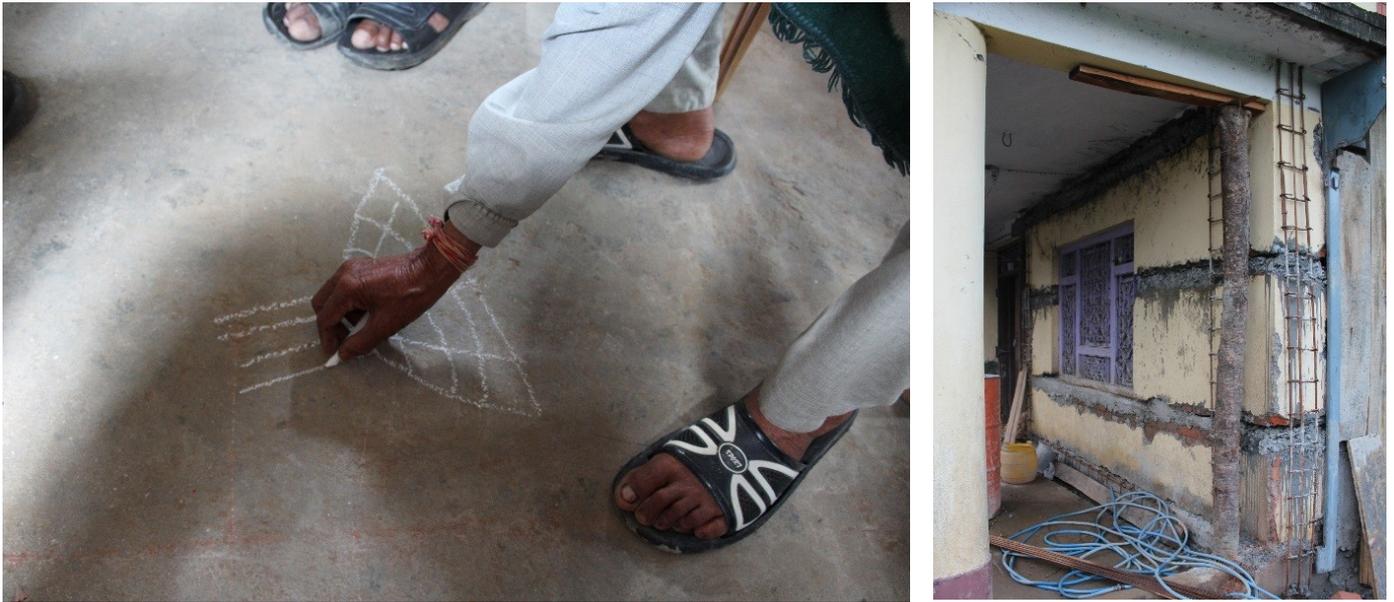
Figure 12. A mason in Bhaktapur drew how they now bent reinforcing steel into foundation footing, rather than simply cutting them at the foundation. The mason explained that he learned this technique as part of his school retrofit training. In North Kathmandu, houses near the school retrofit site were being retrofitted by adding bands and stitches two months after the event. The work was being carried out by local masons who had been trained to retrofit the school. Photo: R. Paci-Green/Risk RED

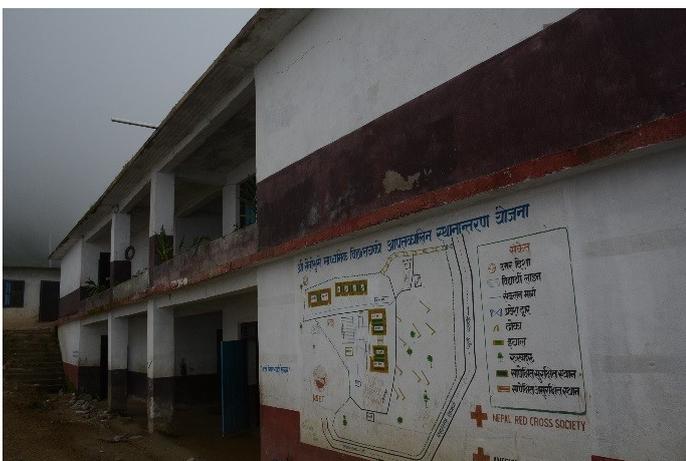
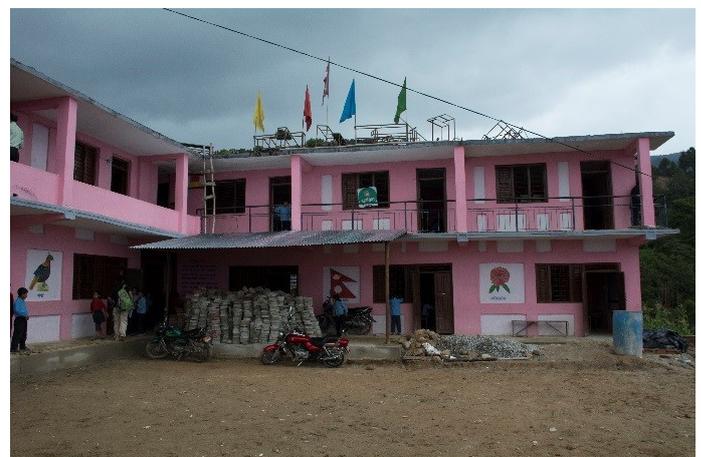
Figure 13. Both schools shown here were successful safer school projects – a new masonry building with lintel and sill bands on the left, and a retrofitted masonry building on the right. Neither provides highly visible signage to alert communities of the safer construction techniques employed, though the school on the left did paint a safe evacuation plan on the building. The lintel and sill bands are barely visible under the white paint in the left photo. The retrofit bands are highlighted in bright pink in the photo on the right, but could have been labelled as earthquake-resistant retrofit bands for an ongoing reminder of the project and of the community’s exposure to earthquake risk. Photo left: R. Paci-Green/Risk RED. Photo right: R. Friedman/Risk RED

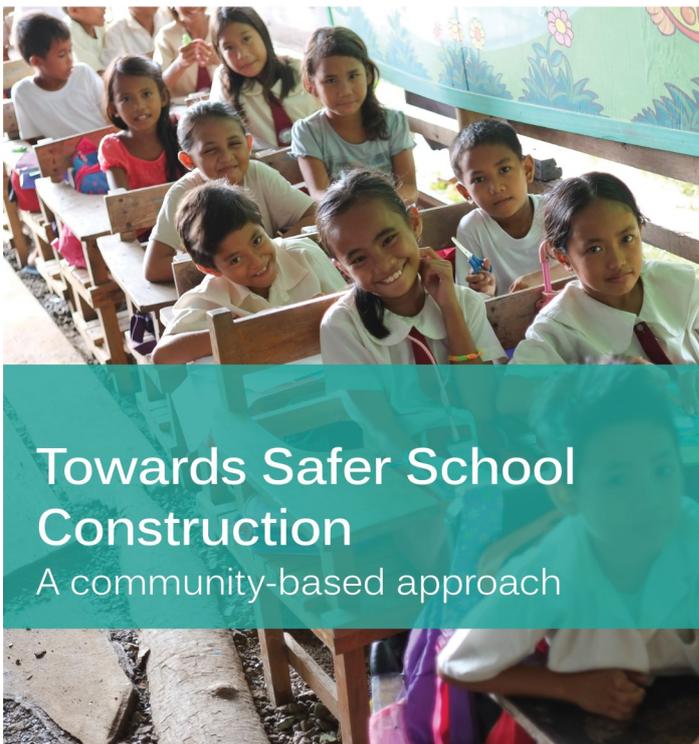
Figure 14. The 2015 publication *Towards Safer School Construction* provided guidance to program managers, donors and agencies supporting school construction in hazard-prone communities. It provides steps for engaging communities and technical experts during mobilisation, planning, design, construction, and post-construction maintenance. The publication can be accessed at: <http://preventionweb.net/go/45179>

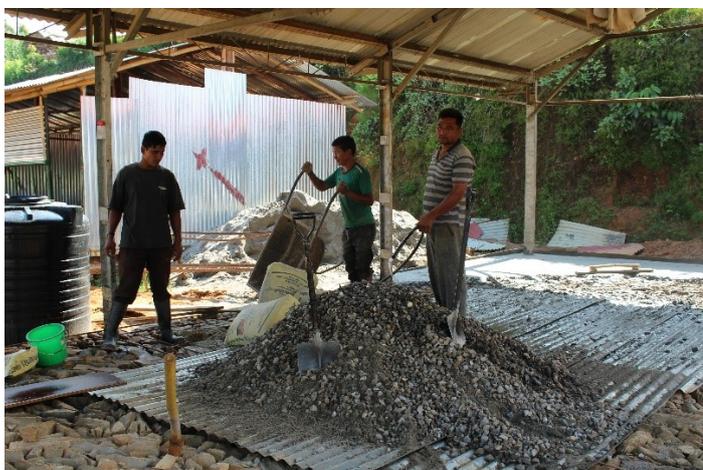
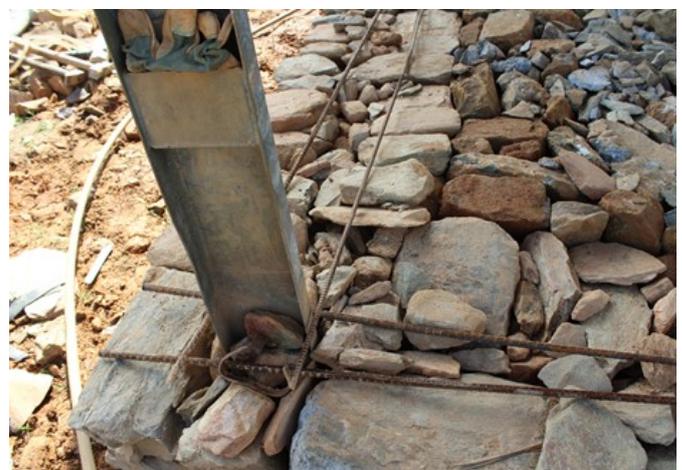
Figure 14. Untrained masons are already rebuilding school buildings without incorporating disaster-resistant construction techniques. The masons here were not measuring concrete materials accurately and were using only large aggregate in their mixture. When asked, the masons said that they learned to lay reinforcing steel bars shown from previous metal frame school construction. They were incorrectly laying rebar on the ground, without spacers, and without bar end hooks. The school buildings of which they spoke had collapsed or been badly damaged. Photo: R. Paci-Green/Risk RED
